**CM308 Clifton Village Dovecote**  
**Condition Survey - Building Fabric**  
**Site Summary**

<b>Reference Number:</b> CM308
<b>Site Name:</b> Clifton Village Dovecote
<b>Address:</b> Village Road
Clifton Village
Nottingham
NG11 8

<b>Survey Date:</b> 15 July 2015
<b>Building Surveyor:</b> D.Solomon and Z. Thantrey
<b>Weather:</b> Dry / bright

**CM308 Clifton Village Dovecote  
Condition Survey - Building Fabric  
Condition Summary**

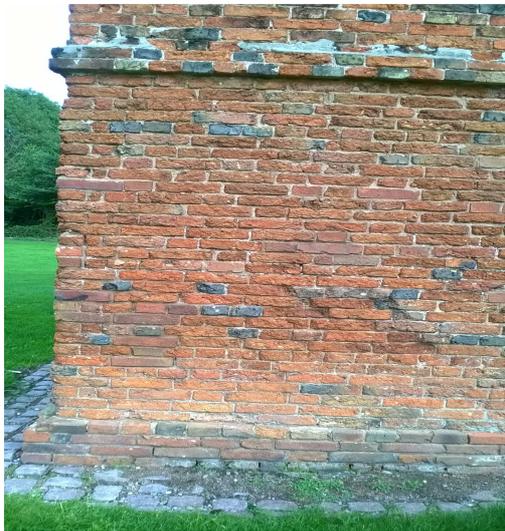
Picture 3 - Granite Setts - vegetation

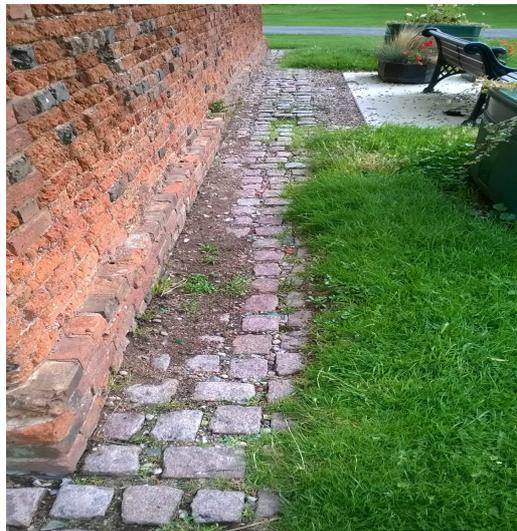
Picture 4 - Granite Setts - replace missing

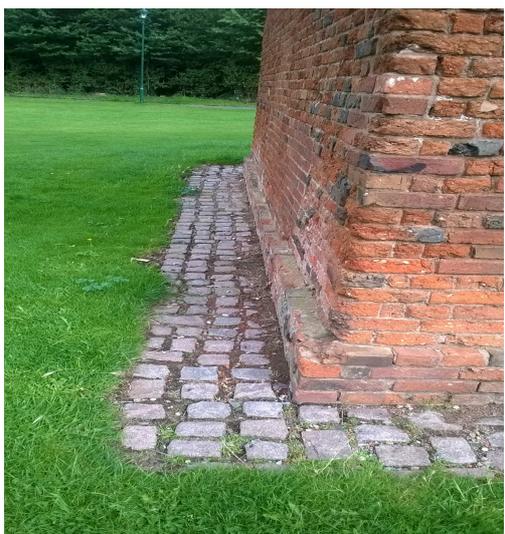
Picture 5 - Granite Setts - repoint

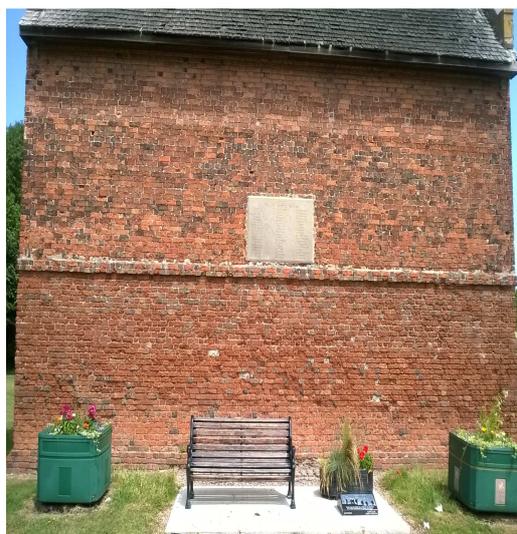
Picture 6 - South Elevation - eroded brickwork and pointing

Bldg.	Fl.	Rm.	Element	Sub-Element	Material/Type	Conditional Defect	Action Required	Comment	Condition	Priority	Quantity	Unit	Unit Cost	SN	Priority 1	Priority 2	Priority 3	Priority 4	Room Area	Photo Ref	
01	0	000	External Areas	Ancillary Premises and Landscaping	Soft Landscaping	Defective	Maintain	Clear vegetation from around building	B	3	35	lm	£3.00				£105.00			3	
01	0	000	External Areas	Paths and Pedestrian Paved Areas	Paving Slabs and Brick Paviers	Missing	Renew	Renew missing granite setts to various areas of footpath around perimeter of building	C	1	4	nr	£25.00		£100.00						4
01	0	000	External Areas	Paths and Pedestrian Paved Areas	Paving Slabs and Brick Paviers	Defective	Patch Repair	Rake out and repoint mortar joints to granite setts around perimeter of building	B / C	3	18	sqm	£25.25				£454.50				5
01	0	000	External Walls Windows and Doors	Wall Structure	Brickwork	Defective	Patch Repair	Carefully chop out eroded bricks to all elevations and replace with new hand made bespoke bricks to match original. Only replace bricks where the face has eroded by more than 10mm	B	3	200	nr	£4.60				£920.00				6

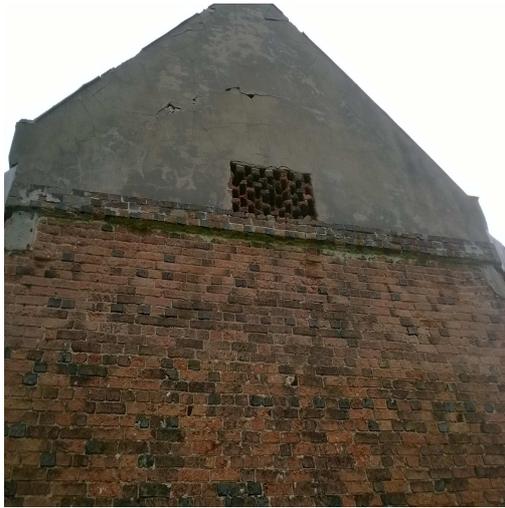
Picture 7 - Gable - honeycomb brickwork

01	0	000	External Walls Windows and Doors	Wall Structure	Brickwork	Defective	Repair	Check and repair loose bricks to honeycomb brickwork openings in each gable.	C	2	10	nr	£10.00			£100.00					7
01	0	000	External Walls Windows and Doors	Wall Structure	Brickwork	Defective	Repoint	Carefully rake out areas of defective mortar joints to a depth of 20mm and repoint with a soft lime putty based mortar in a ratio of 1 part lime to 2½ parts well graded sharp sand (as a guide). Areas of cement pointing should be left in situ if strongly bonded to the brickwork. Only repoint areas of brickwork which have become recessed from the brick face by over 5mm.	C	2	23	sqm	£40.00			£920.00					6
01	0	000	External Walls Windows and Doors	Wall Structure	Brickwork	Cracking	Further Investigation	Carry out further investigation / monitoring of crack to brickwork on south elevation.	B	3	1	nr	£500.00				£500.00				8
01	0	000	External Walls Windows and Doors	External Wall Finishes	Rendered Surface	Defective	Renew	Carefully remove cement render to 2no gable ends to expose brickwork. Inspect condition of exposed brickwork underneath and re-render in lime render if required	D	2	22	sqm	£56.78			£1,249.16					9 & 10

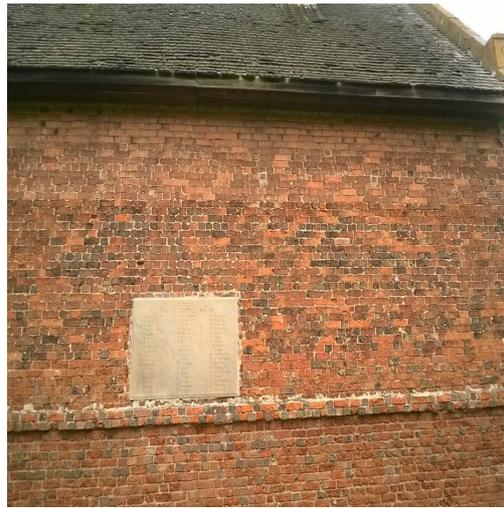
Picture 8 - South Elevation - crack to brickwork

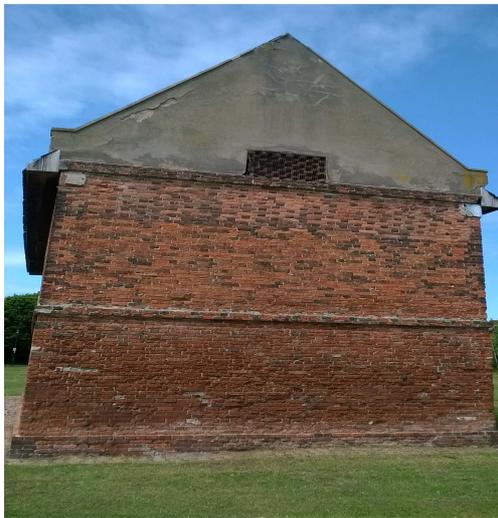
Picture 9 - Gable - rendering

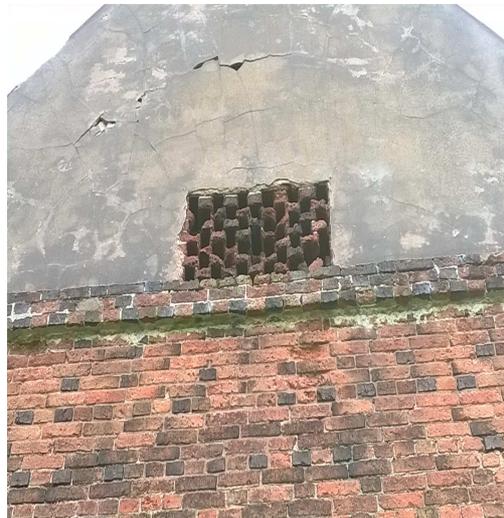
Picture 10 - Gable - rendering

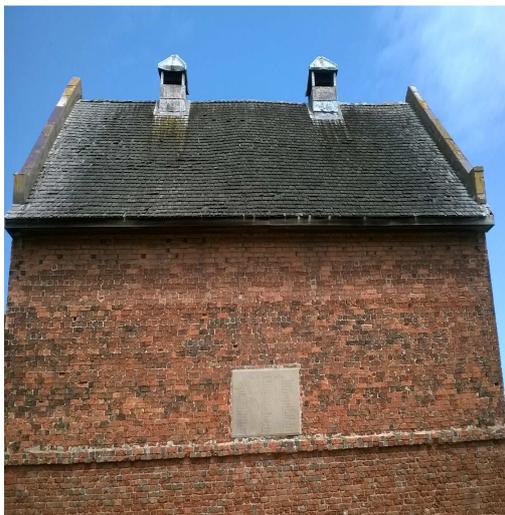
Picture 11 - South Elevation - roof and coping stones

01	0	000	External Walls Windows and Doors	Wall Structure	Stonework	Defective	Renew	Remove eroded coping stones to gable and replace with new stones to match the original origin and design.	C	2	20	lm	£222.23				£4,444.60				11
01	0	000	External Walls Windows and Doors	Wall Structure	Stonework	Good Condition		Stone plaque / roll of honour attached to south elevation has recently been refurbished and is in good condition.	A	4								£0.00			12
01	0	000	Roofs	Pitched Coverings and Insulation		Defective	Renew	Carefully remove existing shingle roof covering and replace with Oak shingles.	D	2	130	sqm	£351.18			£45,653.40					11 & 13
01	0	000	Roofs	Pitched Coverings and Insulation	Pitched Roof Flashings	Defective	Repair	Refix / renew lead soakers to gable / roof junction	C	2	18	lm	£49.00			£882.00					13
01	0	000	Roofs	Pitched Coverings and Insulation		Deteriorated	Repair	Carry out close up examination of 2no gloves, renew and refit leadwork and components as necessary all to match original design. Carry out as part of roofing works.	B	2	2	item	£1,500.00			£3,000.00					14

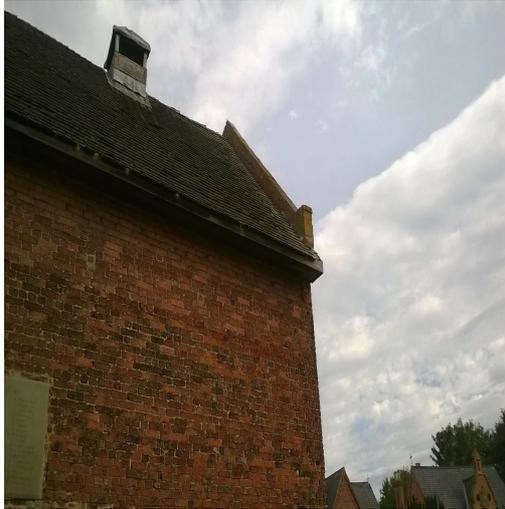
Picture 13 - South Elevation - roof and gable parapet

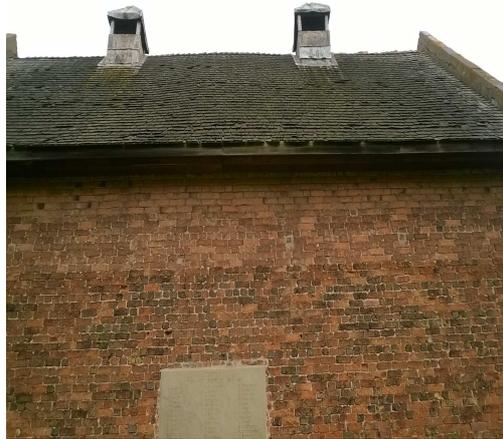
Picture 14 - South Elevation - glovers

01	0	000	Roofs	Pitched Coverings and Insulation		Deteriorated	Renew	Renew mesh to openings of 2no gloves to leave secure. Openings to be double meshed. All mesh to be 16g with 13mm x 13mm hole size, hot dipped galvanised after weaving.	D	2	12	sqm	£70.00			£840.00					14
01	0	000	Roofs	Roof Void	Structural Timber	No Access	Repair	Check condition of structural timbers for rot and wood worm, treat or replace as necessary.	B	3	1	nr	£1,000.00				£1,000.00				15
01	0	000	Roofs	Roof Void		Defective	Repair	Refurbish shutter to each of the two gloves including rope and pulley mechanism, renewing missing components as necessary.	C	2	2	nr	£500.00			£1,000.00					16 & 17
01	0	000	Redecorations	External Areas	Timber Surface	Defective	Redecorate	Prepare and apply black weather coating of bituminous paint to soffits and fascias.	D	2	12	sqm	£25.00			£300.00					18
01	0	000	External Walls Windows and Doors	Window and Door Framing		Defective	Renew	Renew mesh fitted over honeycomb brickwork openings in each gable (internal and external mesh to each opening). All mesh to be 16g with 13mm x 13mm hole size, hot dipped galvanised after weaving.	B	2	2	sqm	£70.00			£140.00					19

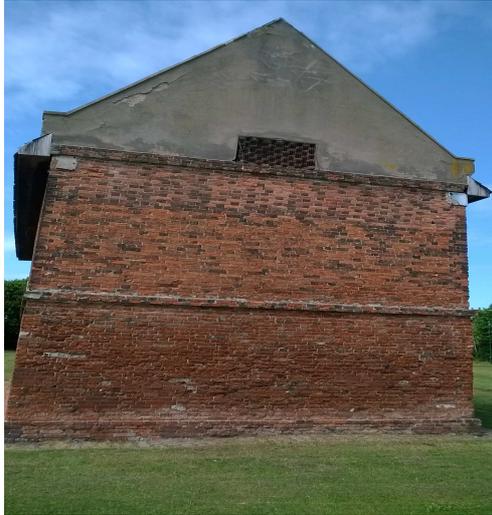
Picture 19 - Gable - honeycomb brickwork

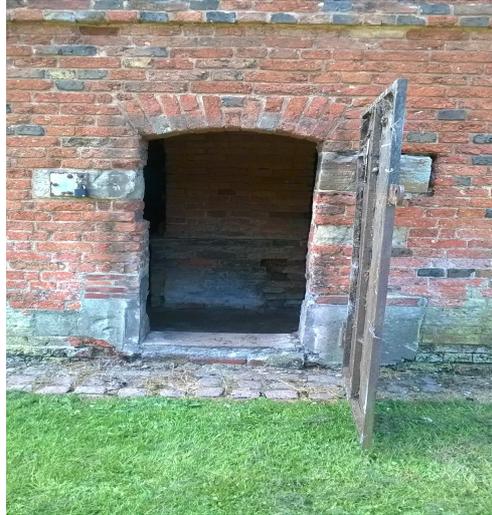
Picture 20 - North Elevation - steel entrance door

01	0	000	External Walls Windows and Doors	Window and Door Framing	Steel Doors	Reasonable Condition	Service	Service and adjust steel door to main entrance so door operates correctly.	B	3	1	item	£100.00				£100.00				20
01	0	000	External Walls Windows and Doors	Window and Door Framing	Steel Doors	Deteriorated	Redecorate	Prepare thoroughly and paint one coat anti corrosive metal primer, and two coats, metal paint to give a black semi gloss finish to door and door furniture (internal and external).	C	3	4	sqm	£25.00				£100.00				21
01	0	000	External Walls Windows and Doors	Window and Door Framing	Softwood Doors	Defective	Repair	Treat internal door frame for woodworm. Door frame is located behind outer steel door.	C	2	2	lm	£45.00			£90.00					22
01	0	002	Internal Walls and Doors	Walls and Partitions	Exposed Brick Wall	Damaged	Patch Repair	Rebuild areas missing brick work to low level of wall to north elevation. New bricks to be hand made bespoke bricks to match original.	C	3	3	sqm	£100.00				£300.00				23 & 24

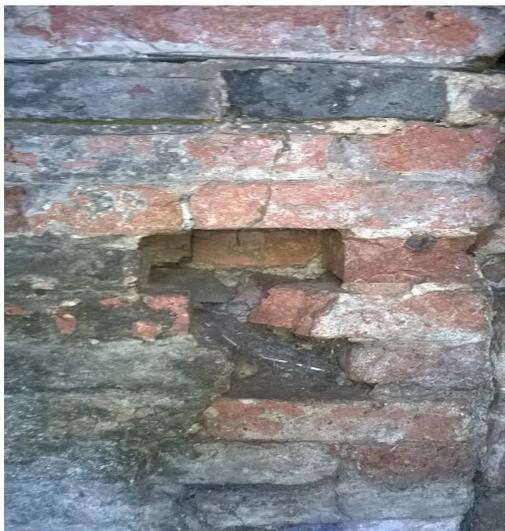
Picture 23 - Internal room 2 - missing brickwork

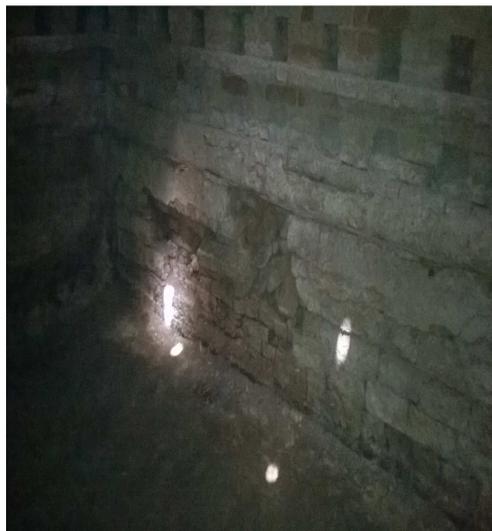
Picture 24 - Internal room 2 - missing brickwork and pointing

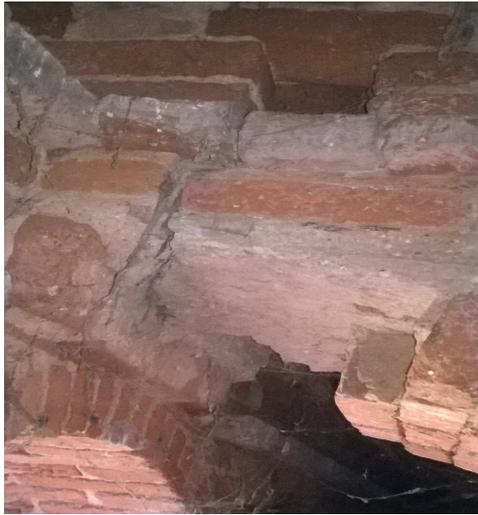
Picture 25 - Internal - missing brickwork and crack to arched doorway
